HRS DOCUMENTATION RECORD COVER SHEET

Name of Site: Ashland/Northern States Power Lakefront
EPA ID No. WISFN0507952

HRS DOCUMENTATION RECORD

Name of Site: Ashland/Northern States Power Lakefront

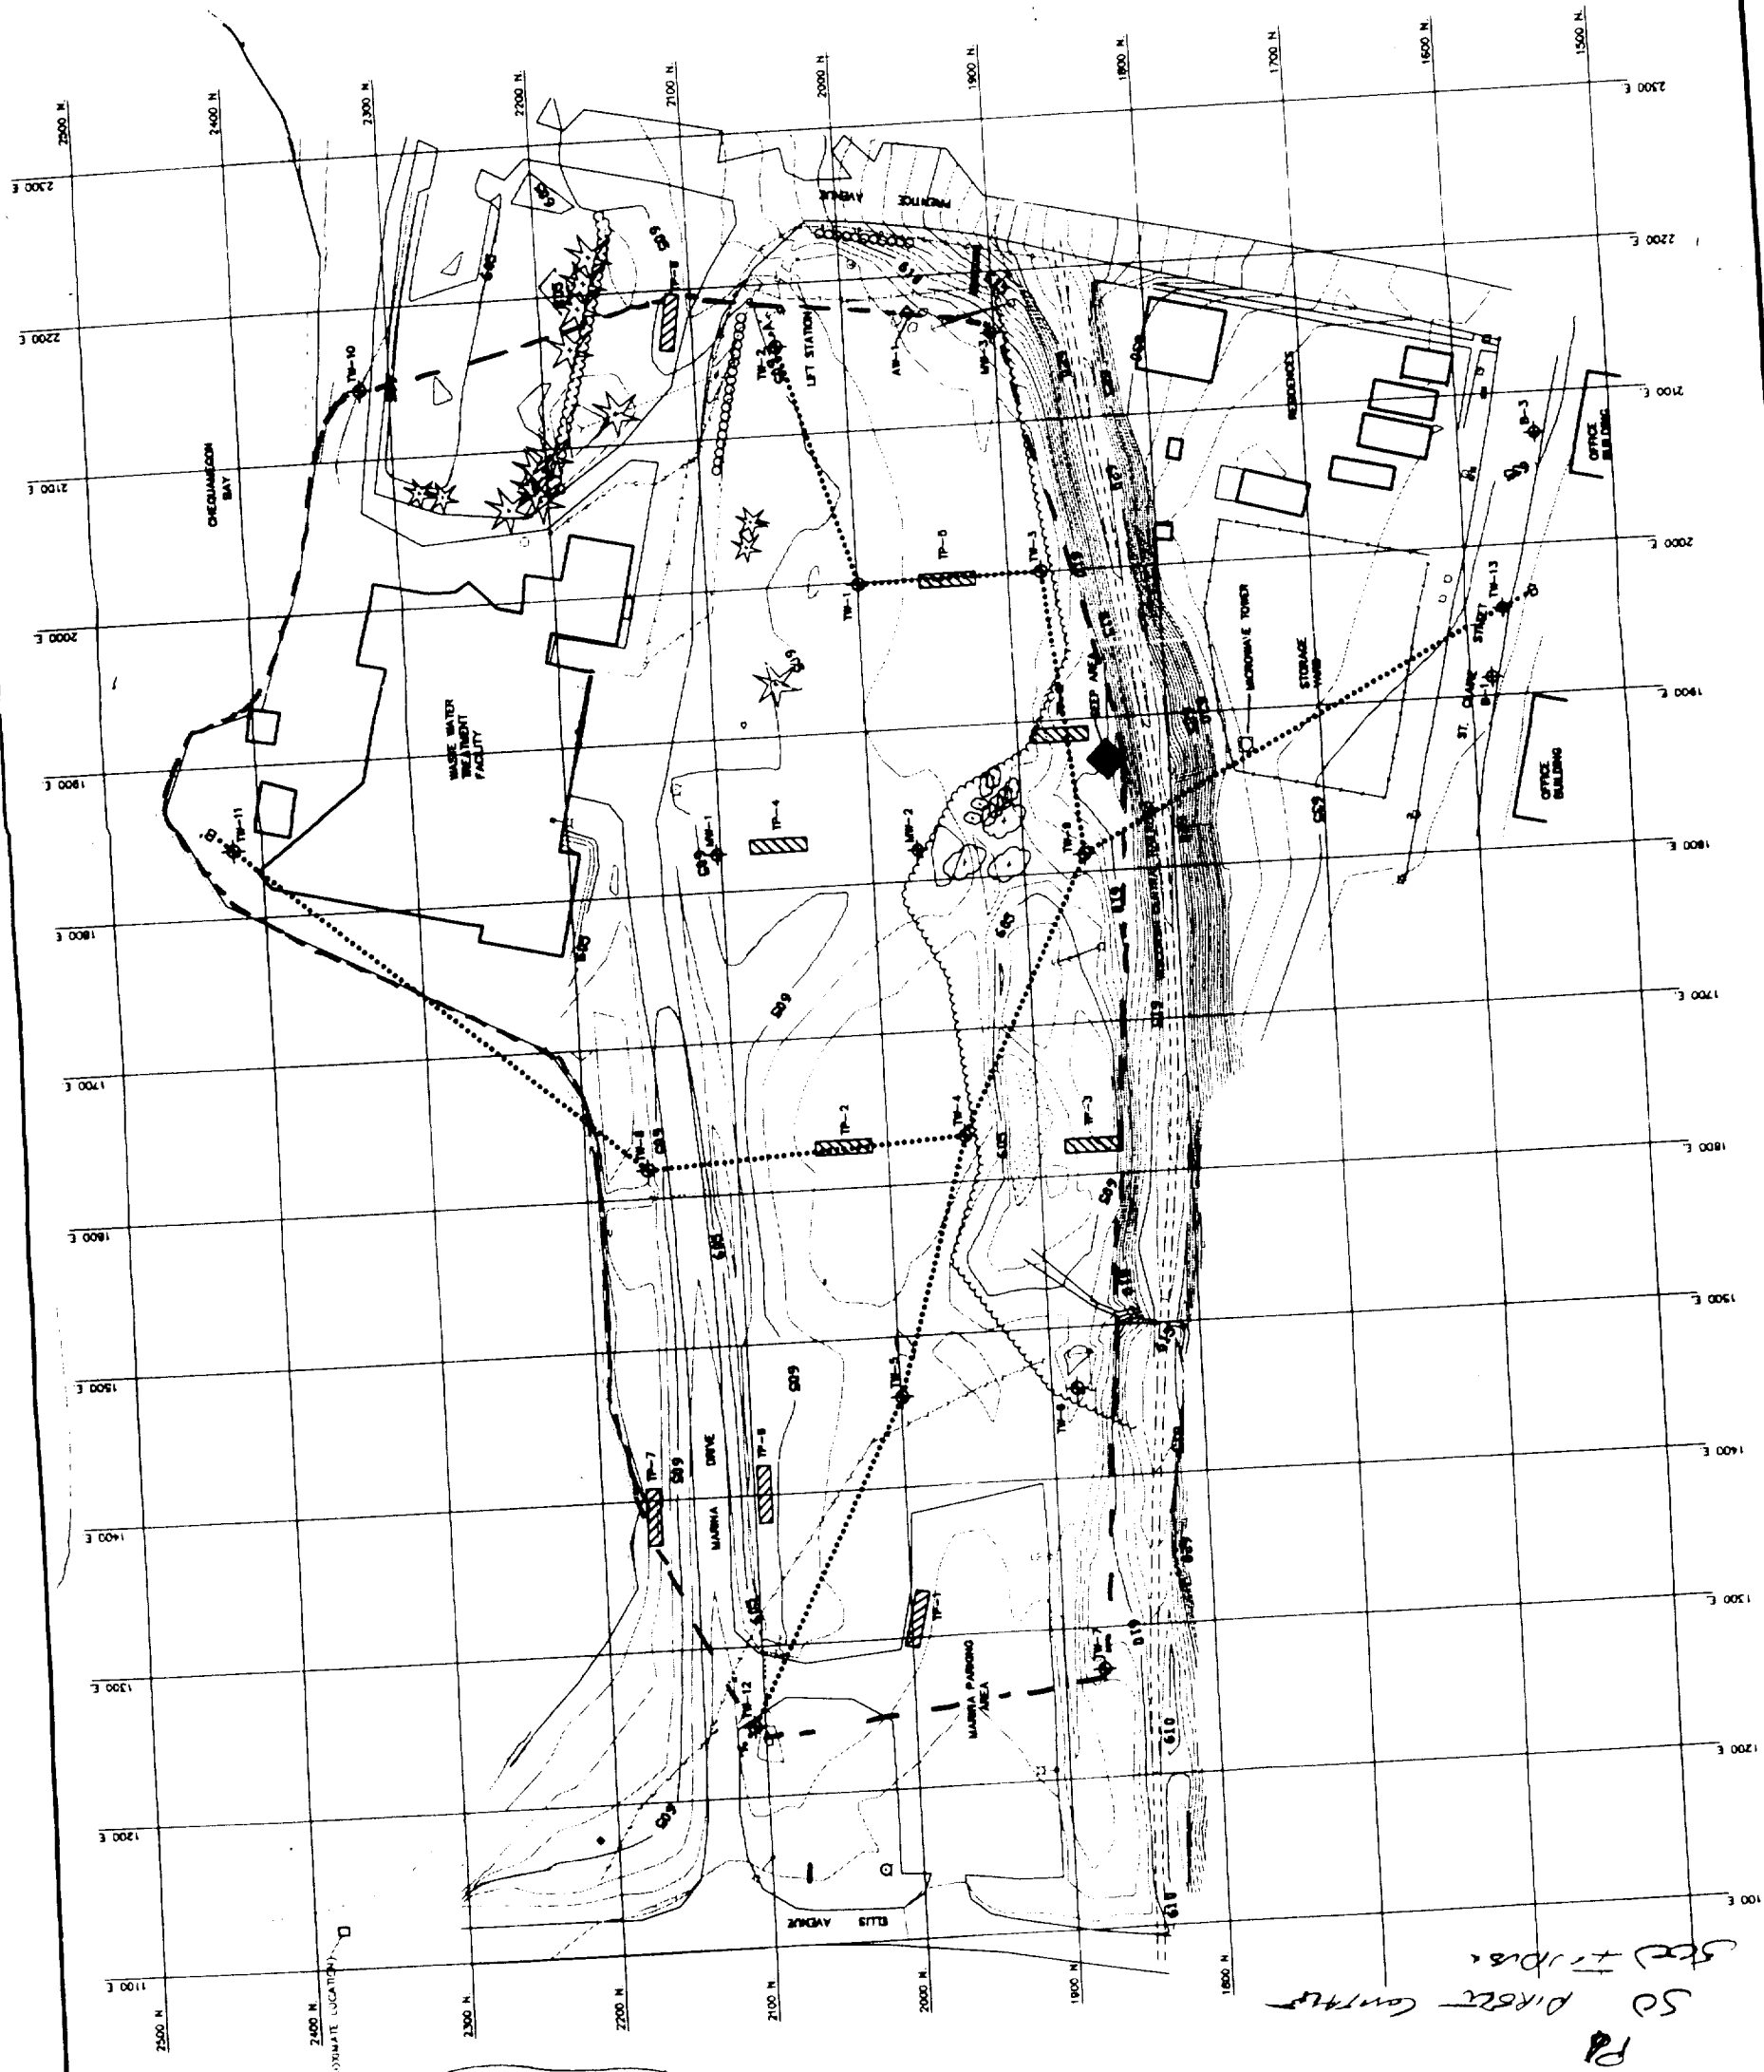
Figure 3 (Source 2)

EXISTING CONDITIONS

A soil sample from TP-2 (test pit number 2) at a depth of 2 to 4 feet is used as a background sample for the Ashland Lakefront/Kreher Park area. This sample is from fill soil and is located in the center of Source 2; because the organic hazardous substances detected in Source 2 are not naturally occurring or ubiquitous substances, Sample TP-2 was selected to document background levels for contamination in Source 2 for HRS scoring. All substances used to document Source 2 are above the background detection limit or significantly above the level in sample TP-2 (Ref. 6, Tables 3 & 4, Appendix F, pages 42 & 43; Figure 3 of HRS documentation record).
